<b>Project Name:</b> Gold King Mine – September 11, 2014	<b>Site Location:</b> Silverton, San Juan County, Colorado	<b>Project No.</b> NA
---	---	--------------------------

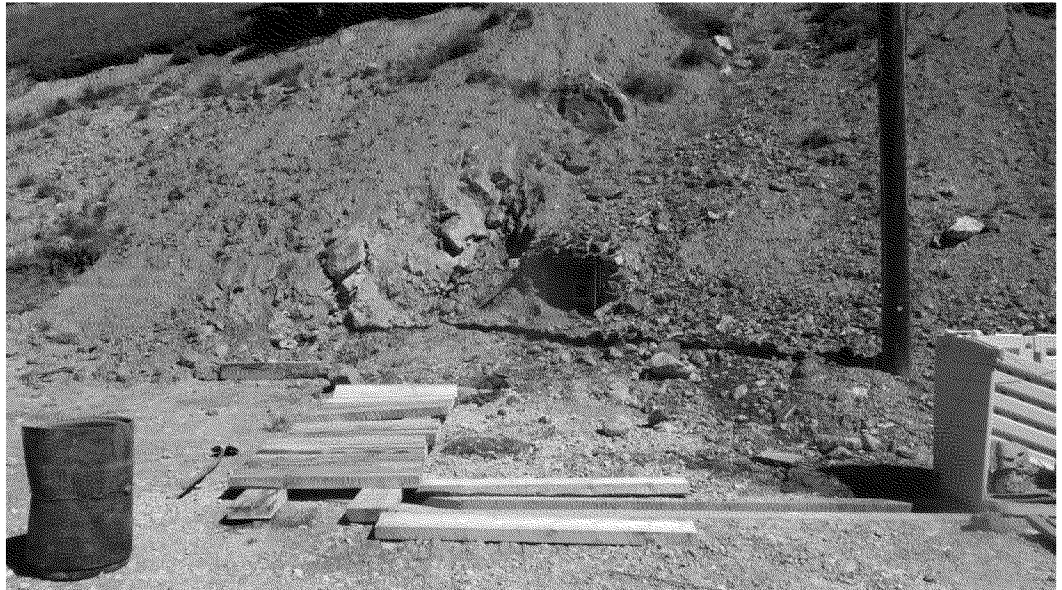
<b>Photo No.</b> <b>1</b>	<b>Date:</b> 09/11/2014

<b>Direction Photo Taken:</b>  North		
<b>Description:</b>  Gold King Mine prior to 2014 site work. Photo taken on 9/11/2014 at 12:37 pm prior to start of work. 3-inch Parshall flume is at the right of the photo, in the plastic structure.

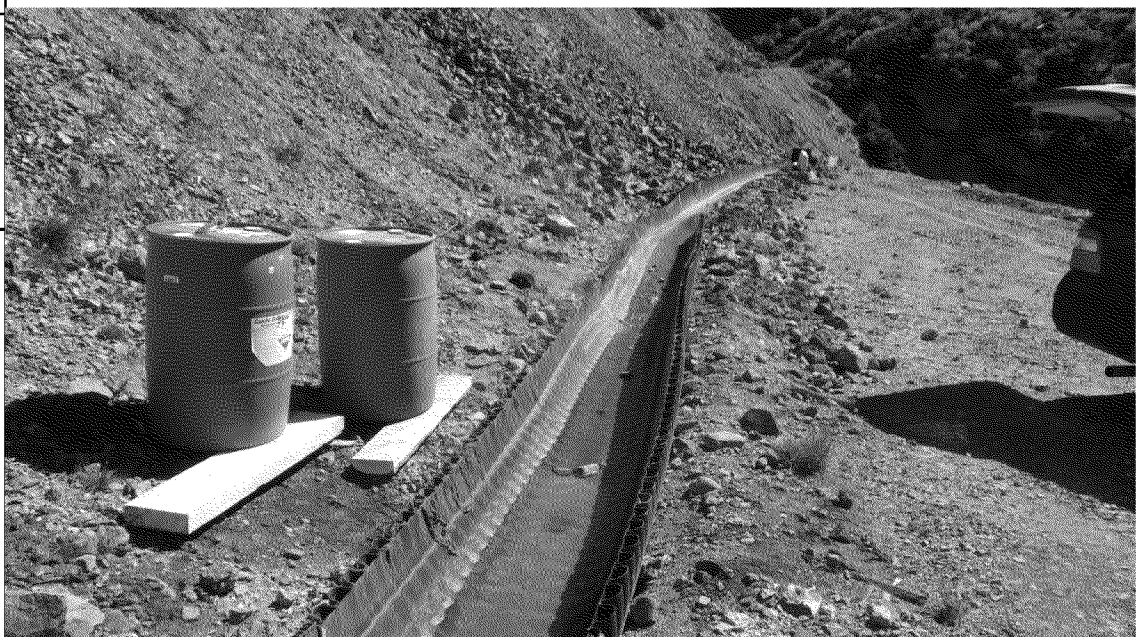
<b>Photo No.</b> <b>2</b>	<b>Date:</b> 09/11/2014

<b>Direction Photo Taken:</b>  East		
<b>Description:</b>  Gold King Mine prior to 2014 site work. Photo taken on 9/11/2014 at 12:28 prior to start of work. Low flow in discharge channel.

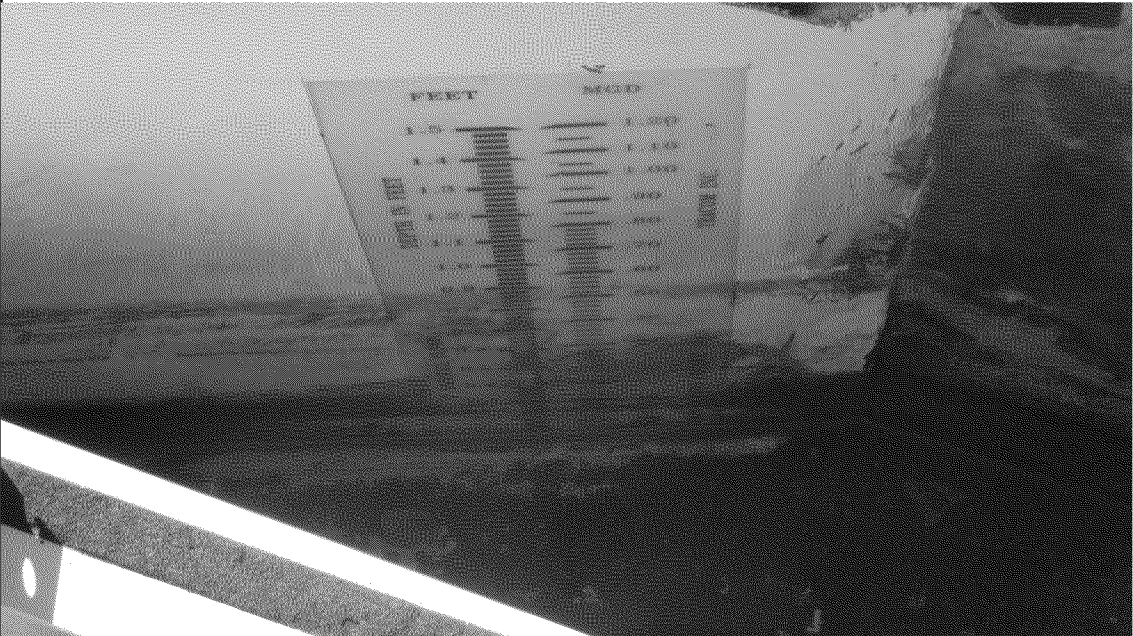
<b>Photo No.</b> <b>3</b>	<b>Date:</b> 09/11/2014

<b>Direction Photo Taken:</b>  South		
<b>Description:</b>  Gold King Mine 3-inch Parshall flume. Note low flow in channel. Photo taken on 9/11/2014 at 12:42 prior to the start of work. Water is at 0.1 feet, which corresponds to 12.55 gallons per minute flow.

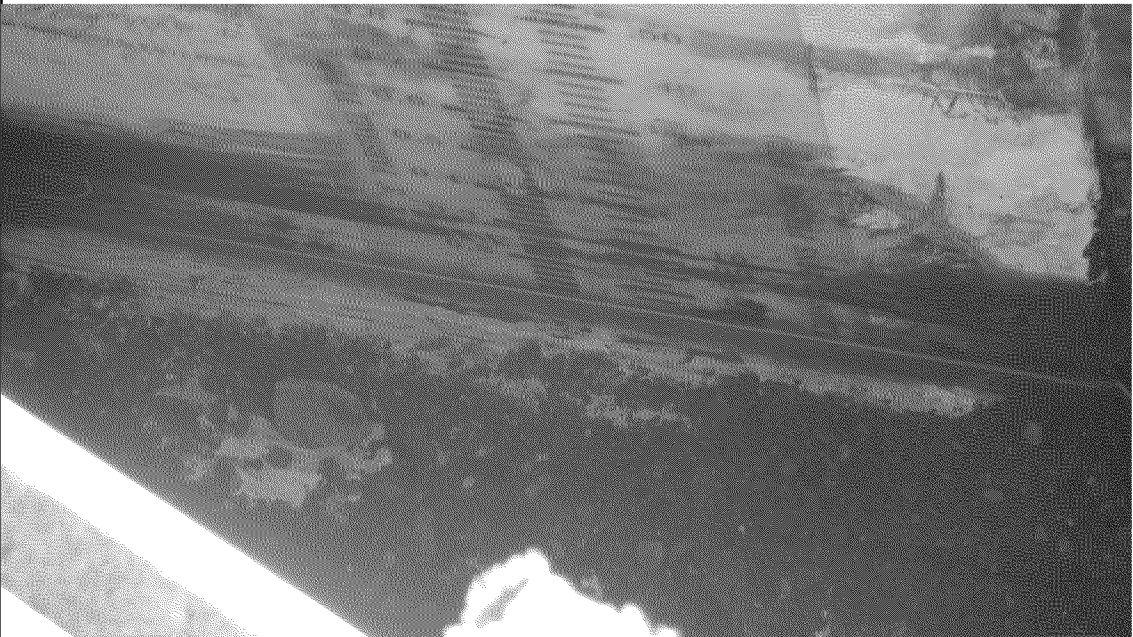
<b>Photo No.</b> <b>4</b>	<b>Date:</b> 09/11/2014

<b>Direction Photo Taken:</b>  South		
<b>Description:</b>  Gold King Mine 3-inch Parshall flume. Note low flow in channel. Photo taken on 9/11/2014 at 12:42 prior to the start of work. Water is at 0.1 feet, which corresponds to 12.55 gallons per minute flow.

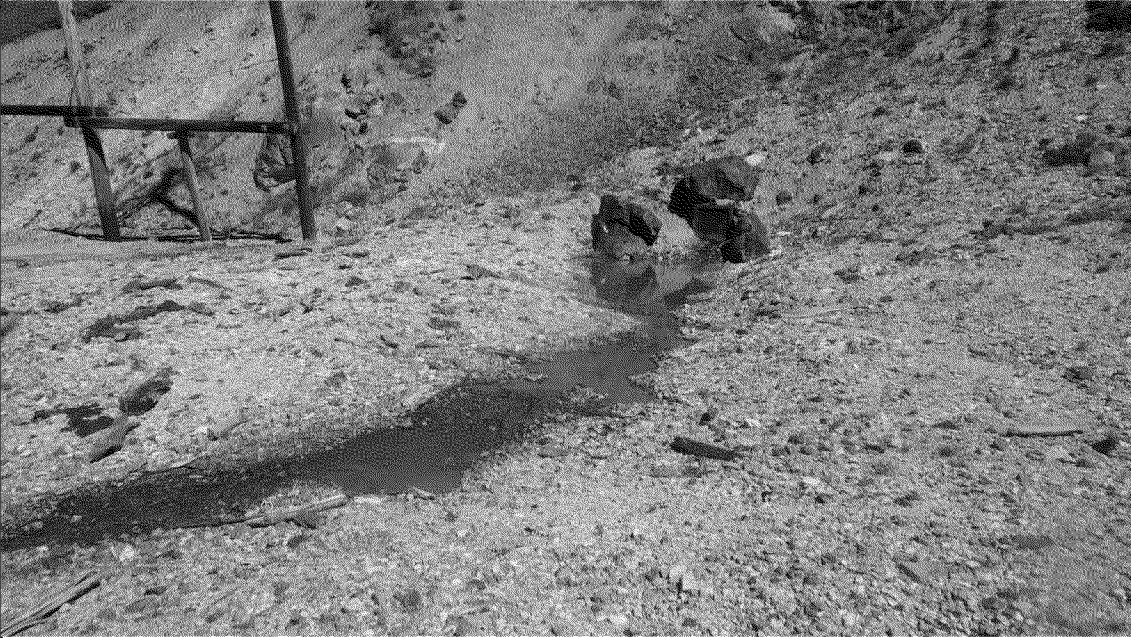
<b>Photo No.</b> <b>5</b>	<b>Date:</b> 09/11/2014	
<b>Direction Photo Taken:</b>  Northwest

<b>Description:</b>  Small amount of flow from side adit approximately 100 feet west of main adit/flume. Photo taken on 9/11/2014 at 12:53.		
<b>Photo No.</b> <b>6</b>	<b>Date:</b> 09/11/2014	
<b>Direction Photo Taken:</b>  Northwest

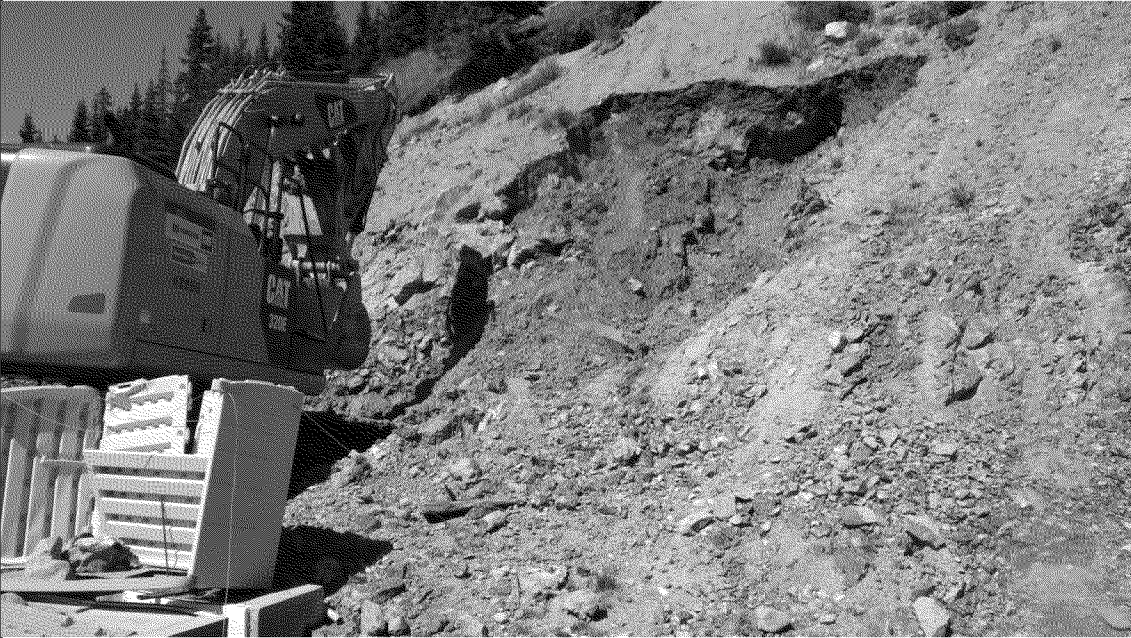
<b>Description:</b>  Start of 2014 excavation work. Photo taken on 9/11/2014 at 16:10.
